ADVANCE REPORT

SEDIMENTATION SURVEY OF LAKE BOONEVILLE

BOONEVILLE, ARKANSAS

November 22 - December 4, 1935

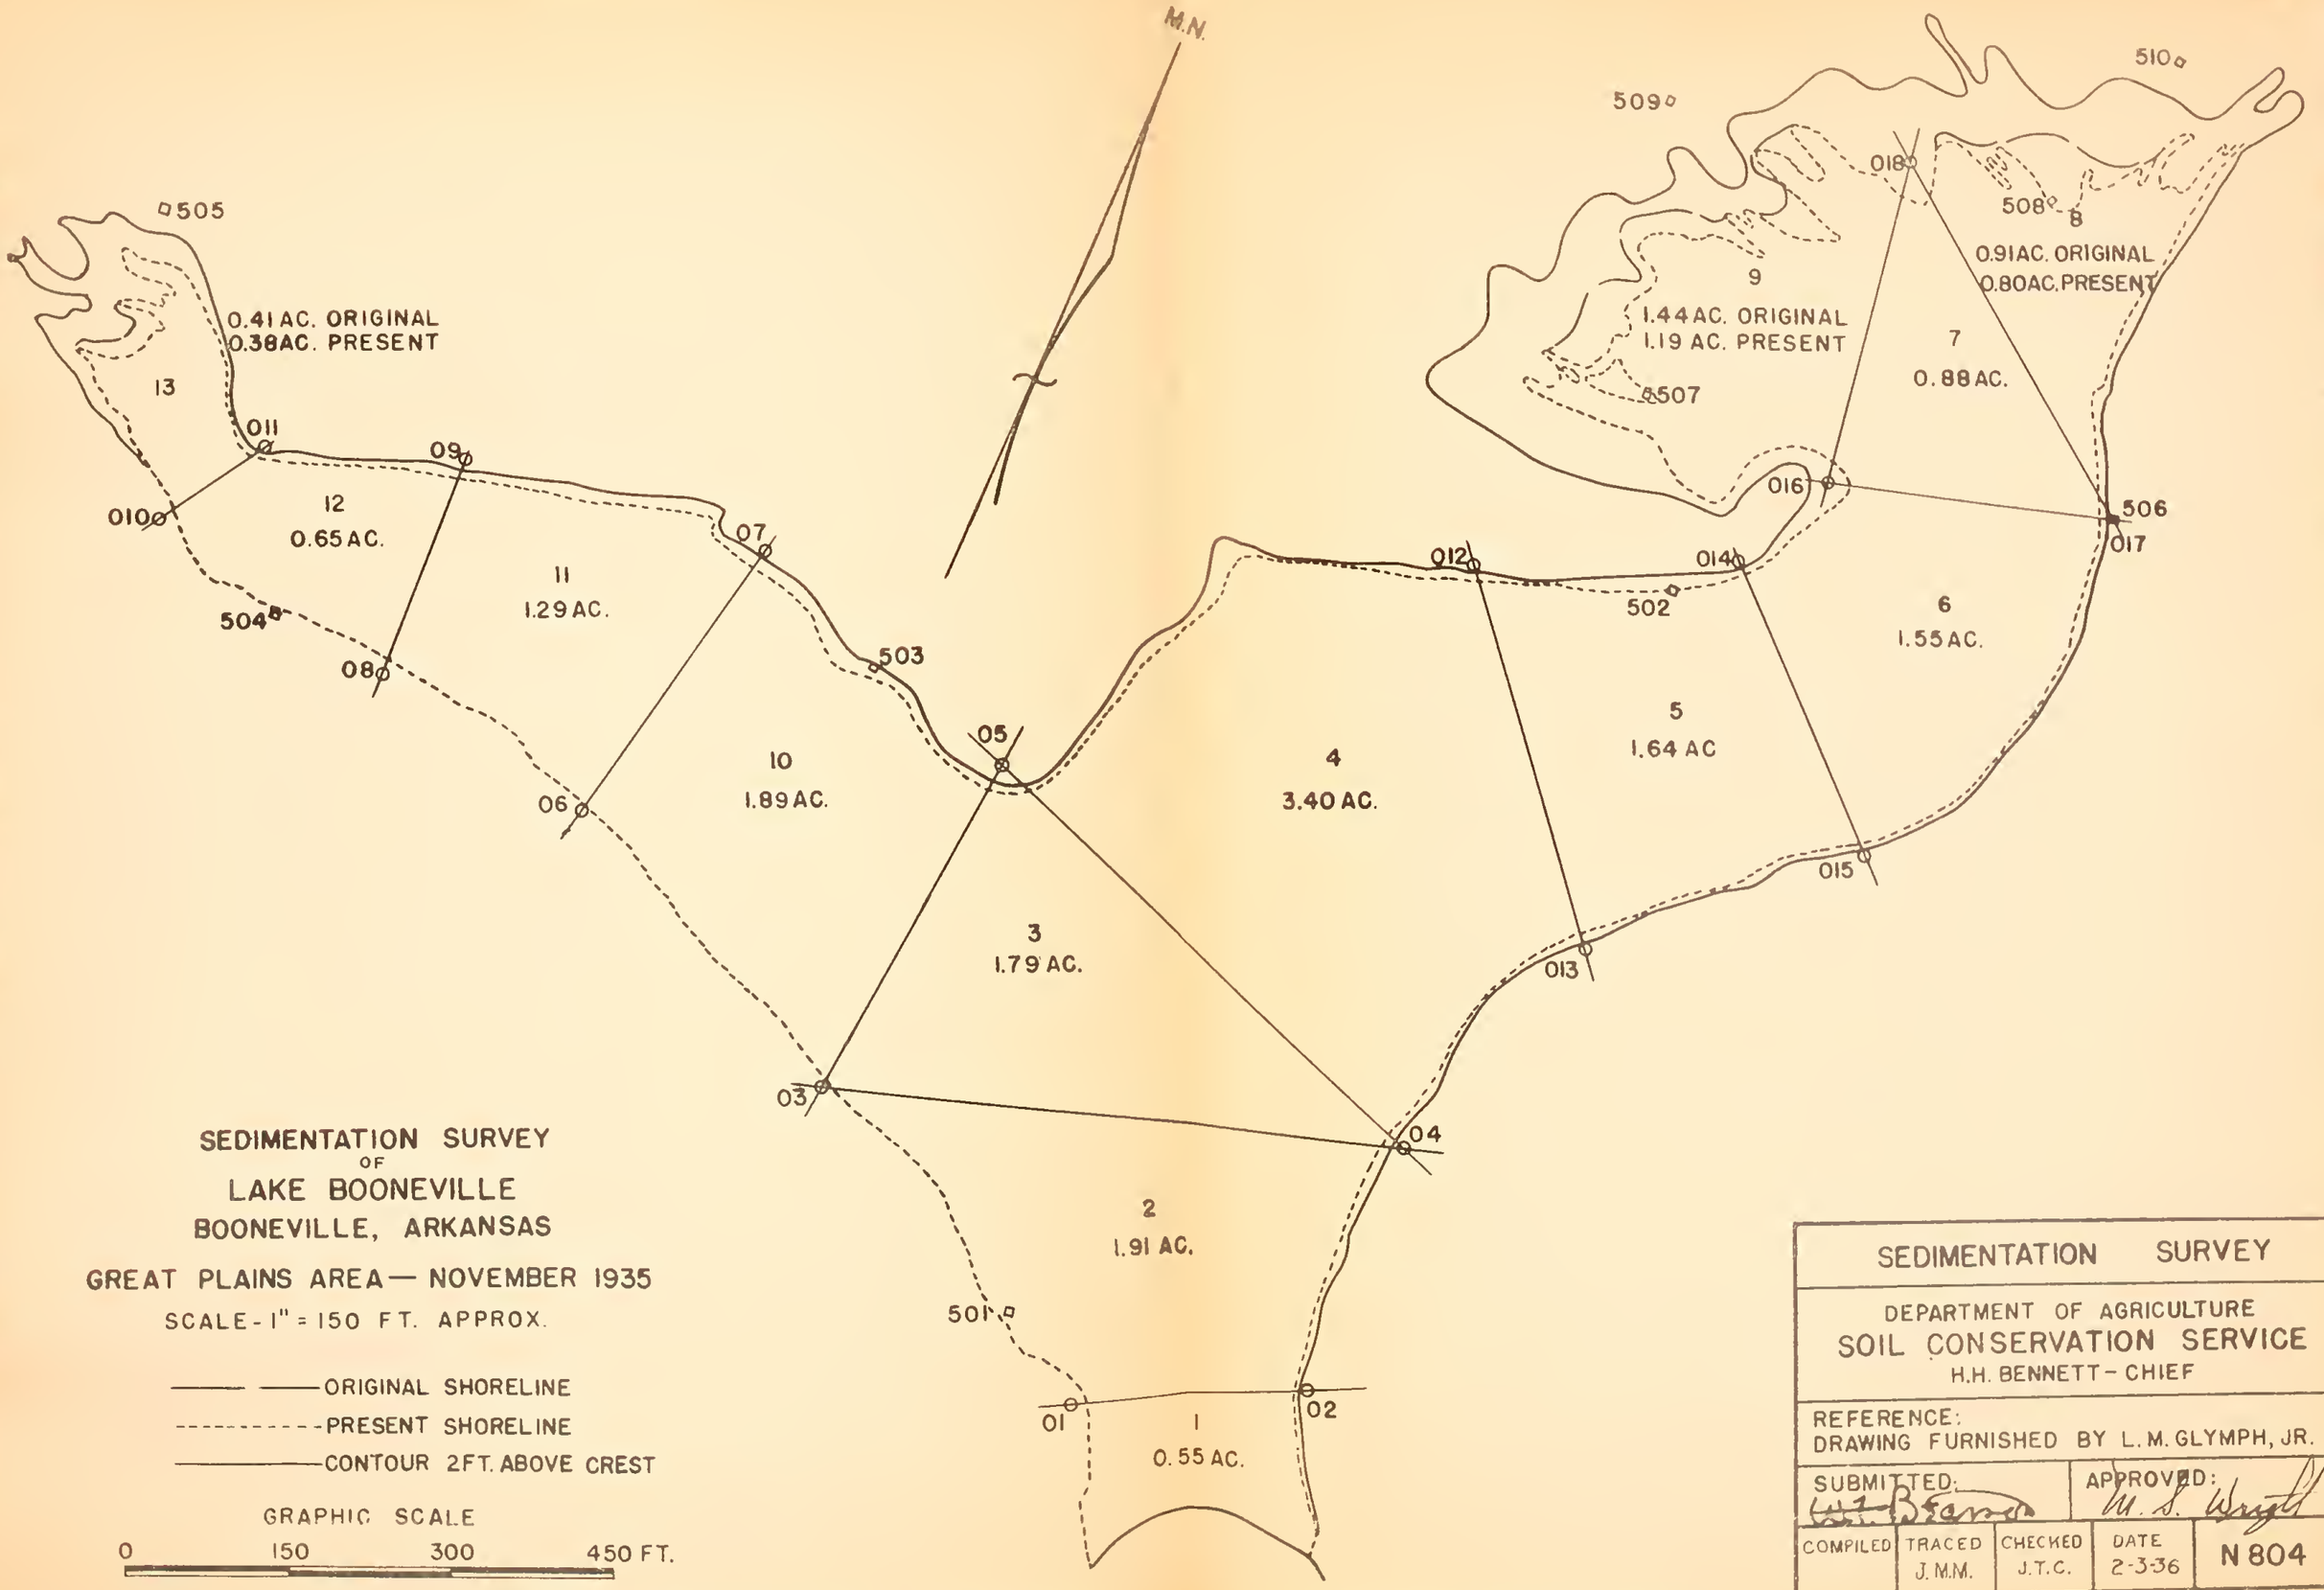
SEDIMENTATION SURVEY
OF
LAKE BOONEVILLE
BOONEVILLE, ARKANSAS

Because of distinct differences between pre-lake and lake sediments and the well defined shore lines, the quantitative determinations of this survey have a relatively high order of accuracy. Field work included mapping the crest level shore line on a scale of 100 feet to the inch by plane-table and telescopic alidade. The comparatively small surface area made it unnecessary to establish a triangulation system. Stations used in primary control were first established by stadia readings and then orientation at each new set-up was checked by back sight on as many previously located points as possible. All survey points were marked in the field with iron pipe and numbered to conform with the system used on the plane-table sheet. During the period of mapping, the water level was generally at crest elevation which facilitated the accuracy, ease, and speed with which the survey was made. On the completed map two contour lines are shown, the crest level line and a contour two feet higher than crest.

Around the entrances of tributary streams into the reservoir, the position of the shore line has changed due to the accumulation of sediment at and above the original crest level elevation. In these areas, the original shore line was mapped by interpolation between numerous well distributed auger borings in which the elevation of old soil was definitely established. The original shore line, traced in this manner, is shown on the accompanying map by a distinctive line.
